Administration Building 117 N. Second Street Goshen, Indiana 46528

Goshen Administration Building

2024

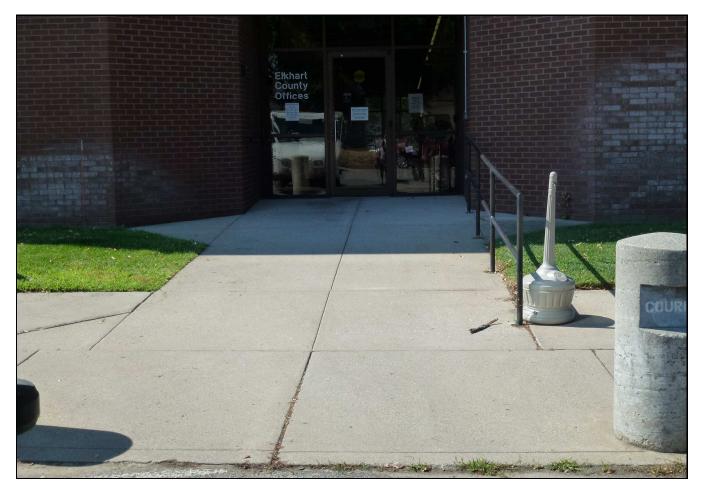
01.Goshen Admin Ramp

| Location | | Structural Inconsistencies | | Recommended Corrections/Modifications to Provide Access | Technical Information | | | Finalized Actions | | |
|---|---|---|--|--|---|---|---|---|---|---|
| Location 1. Ramps | Photo 1 | Identified Issue Ramps longer than 6 feet, do not have railings on both sides, right side only. | ADAAG Specification | ADAAG requires hnadrails on both sides of a ramp if the ramp run has a rise greater than 6 inches or a horizontal projection greater than 72 inches. Add handrail to left side. | L: Ramp slope is accessible and handrail is provided on one side. | Improvement Cost | ອງ ກາວ Buippung Elkhart County General Fund | Finalized Correction | Anticipated Date of Completion | Date of Completion |
| 2. Ramps | 1 | Ramps are not non-slip. | 4.5.1 | ADAAG requires ground and floor surfaces along accessible routes and in accessible rooms and spaces including floors, walks, ramps, stairs, curb ramps, shall be stable, frim, and slip-resistant. Add non-slip surface material. | M: Could add sign about slippery surface in mean time. | \$1,000 | Elkhart County General Fund | Slip resistant material installed. | | Sep-14 |

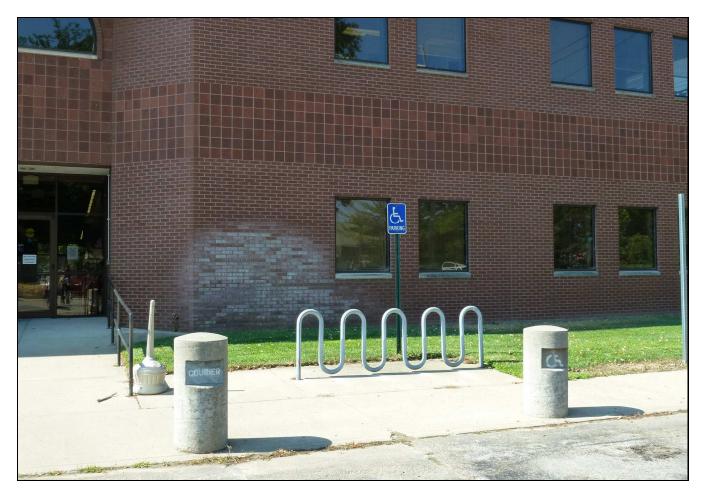
02.Goshen Admin Parking

| Location | | Structural Inconsistencies | | Recommended Corrections/Modifications to Provide Access | Technical Information | | | Finalized Actions | | |
|---|---|---|--|--|---|---|---|---|---|---|
| 3. Parking | | No "Van Accessible" sign at van accessible parking space. No enforcement procedure for accessible parking. | | ADAAG requires accessible parking spaces to be located in each parking lot. Accessible parking spaces are required to have upright signage that incluces the symbol of a accessibility and van accessible signage where required. Add one "Van Accessible" sign. Enforce parking regulations. | L: Van spaces are provided, just no signage. May be snow in the way and not known w/out signs. | \$50 | Elkhart County General Fund | Van accessible sign installed | | Jul-14 |

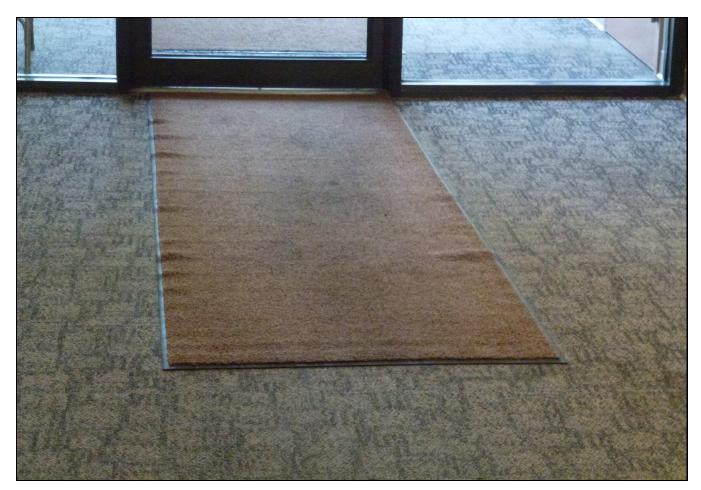
| Location | | Structural Inconsistencies | | Recommended Corrections/Modifications to Provide Access | Technical Information | | | Finalized Actions | | |
|---|---|---|--|--|---|---|---|---|---|---|
| 4. Entrance | 4 | Edges are not securely installed to help minimize tripping hazards. | | ADAAG requires if carpet or carpet tile is used on a ground floor or surface, than it shall be securely attached. Secure carpetingor mats at edges. | H: This can easily be fixed with little cost. | \$50 | Elkhart County General Fund | All removed | | Jul-15 |

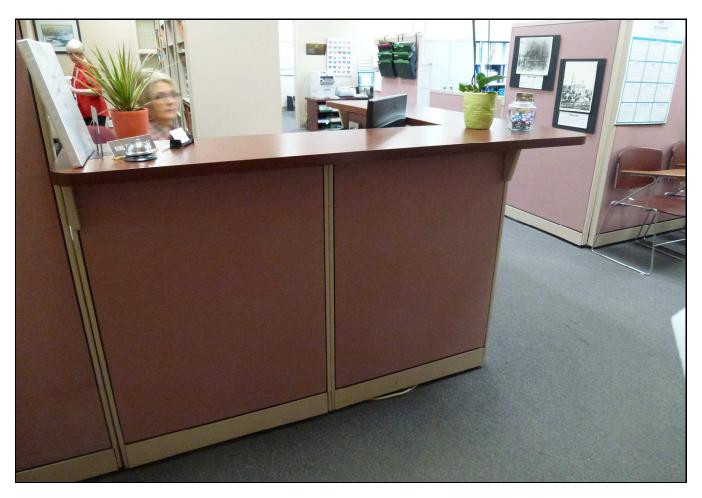
05.Goshen Admin Counter

| Location | | Structural Inconsistencies | | Recommended Corrections/Modifications | Technical Information | | | Finalized Actions | | |
|---|---|--|---|---|---|---|---|--|---|---|
| Location 5. Counters | Photo 2 | Identified Issue At each type of cashier counter, there is a portion of the maincounter that is greater than 36 inches high. | 5.4 ADAAG Specification | ADAAG requires in areas used for transactions where counters have cash registers, at least one of each type shall have a portion of the counter which is at least 36 inches in length with a maximum height of 36 inches above the finish floor. Lower section of the counter. | M: Majority of customers use these counters. L: in some cases when cashiers can easily walk around. | Cost Cost | aunos Bulipung Elkhart County General Fund | Finalized Correction Some counters removed | Anticipated Date of Completion | Date of Completion |

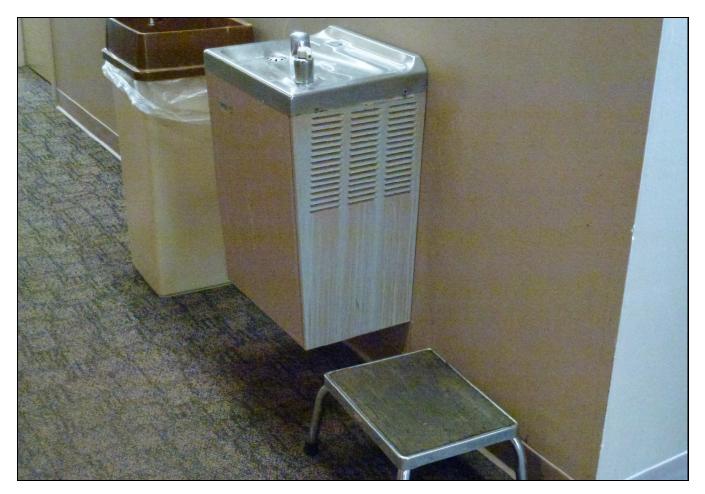
| Location | | Structural Inconsistencies | | Recommended Corrections/Modifications | Technical Information | | | Finalized Actions | | |
|---|---|--|---|---|---|---|---|--|---|---|
| 6. Drinking Fountain | 6 | Drinking fountain does not have minimum clear floor space of at least 30 by 48 inches in front. | 4.15.5 | ADAAG requires fountains have a minimum clear floor space of 30 by 48 inches to allow a person in a wheelchair to approach the unit facing forward. Clear more room in order to meet minimum requirements. | L: Drinking | \$150 | Elkhart County General Fund | Remove | 2023 | |
| 7. Drinking Fountain | 6 | | | ADAAG requires spouts shall be no higher than 36 inches, measured from the floor to spout outlet. Controls shall comply with 4.27.4 (Operable with closed fist). Unit controls shall be front mounted or side mounted near the front edge. Replace controls and lower fountain height. (or remove fountain) | L: Drinking fountains are not required. | \$150 | Elkhart County General Fund | Remove | 2023 | |
