Health Department, Elkhart
608 Oakland Avenue
Elkhart, Indiana 46516

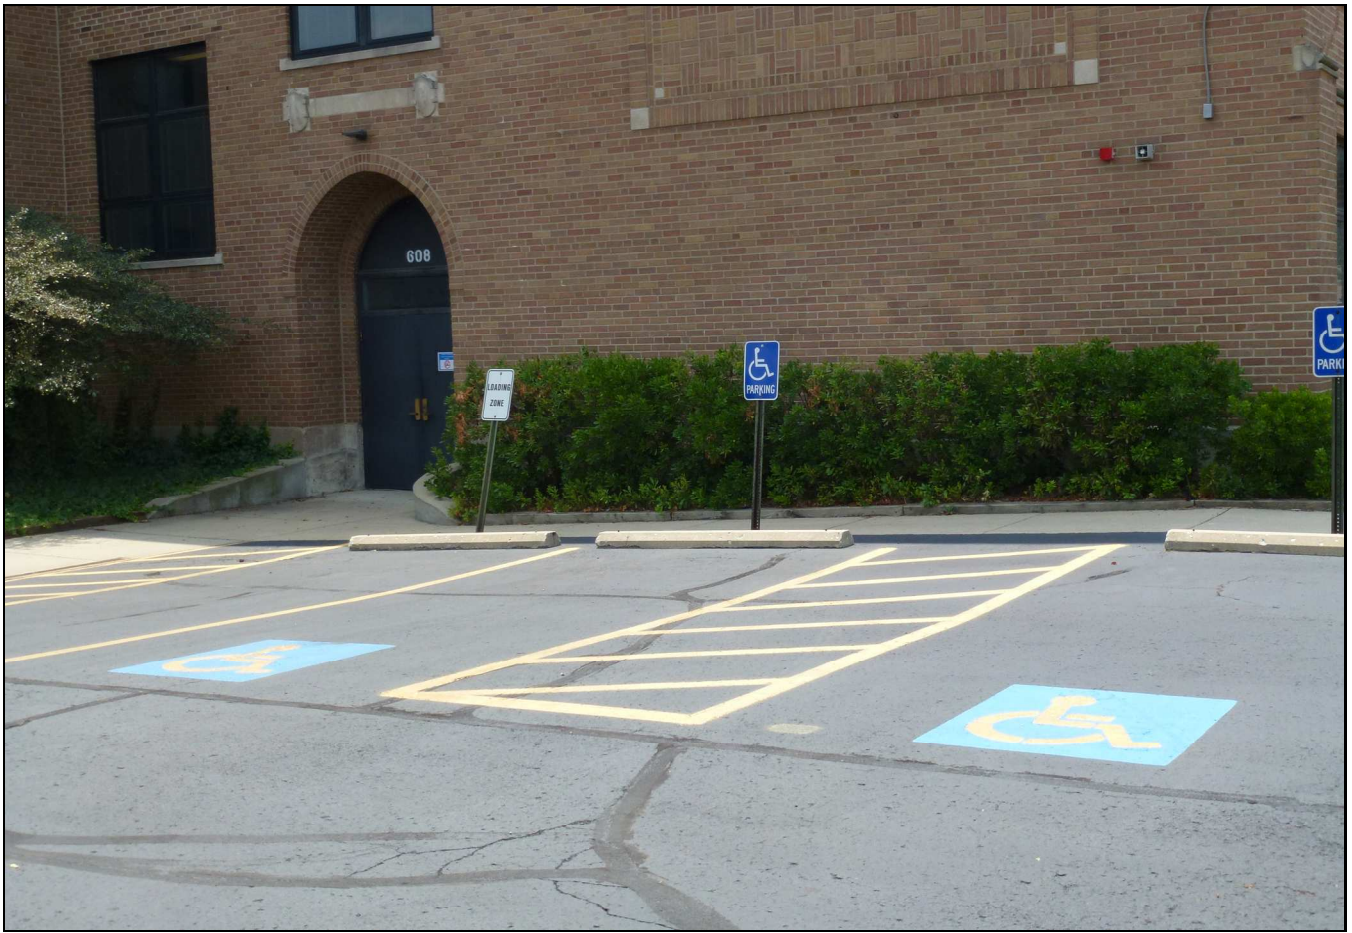
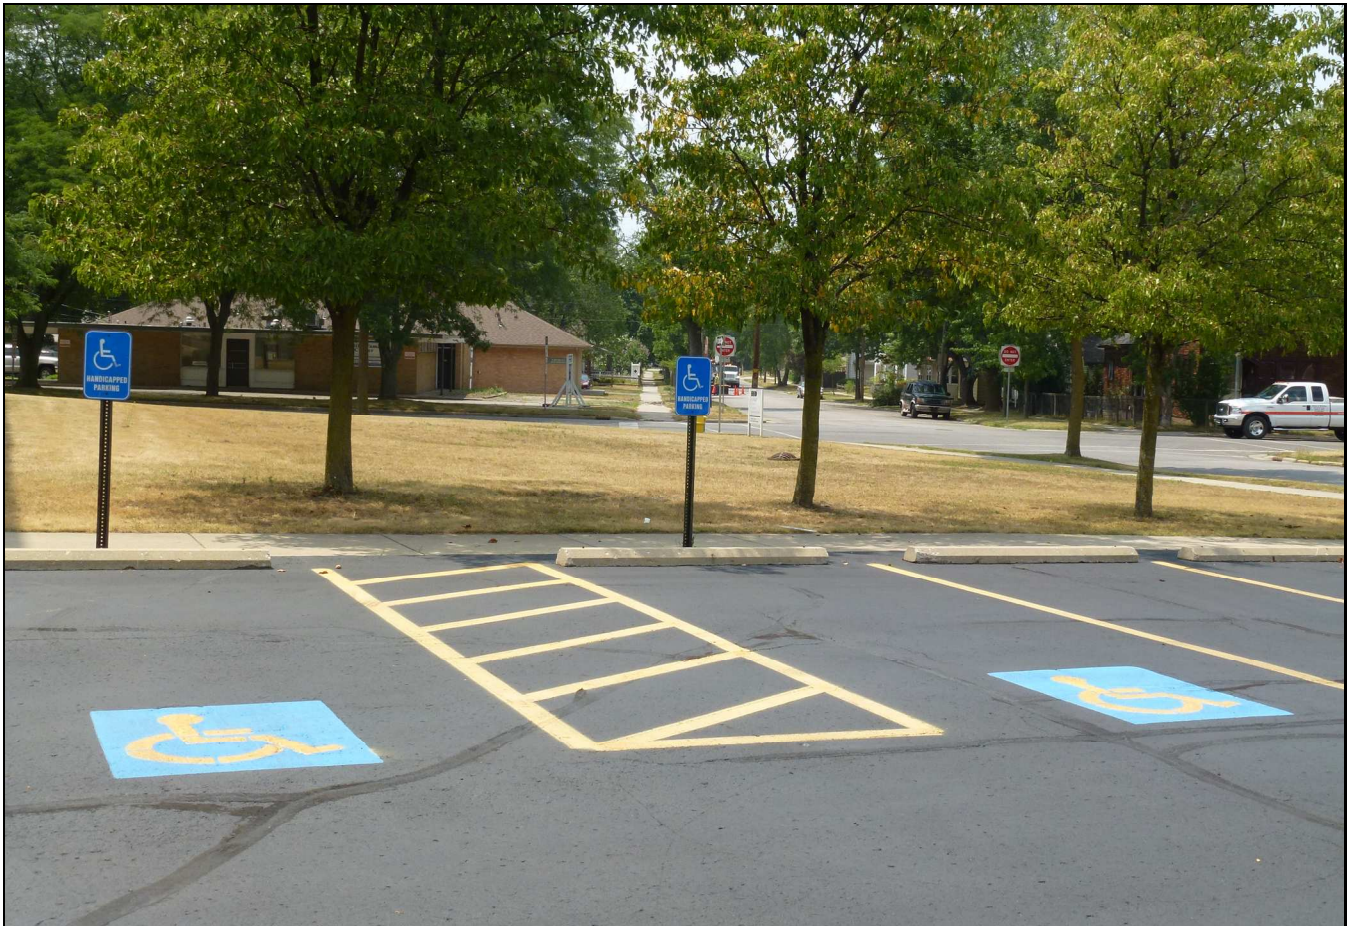
01. Elkhart Health Dept Accessible Parking (2)

1. Parking	1, 2	No "Van Accessible" sign at van accessible parking space. No enforcement procedure for accessible parking	4.6.4	ADAAG requires accessible parking spaces to be located in each parking lot. Accessible parking spaces are required to have upright signage that includes the symbol of a accessibility and van accessible signage where required. Add one "Van Accessible" sign. Enforce parking regulations.	L: Space is adequate for vans, just no sign posted.	\$50	Elkhart County General Fund	Van accessible sign installed		Jul-14

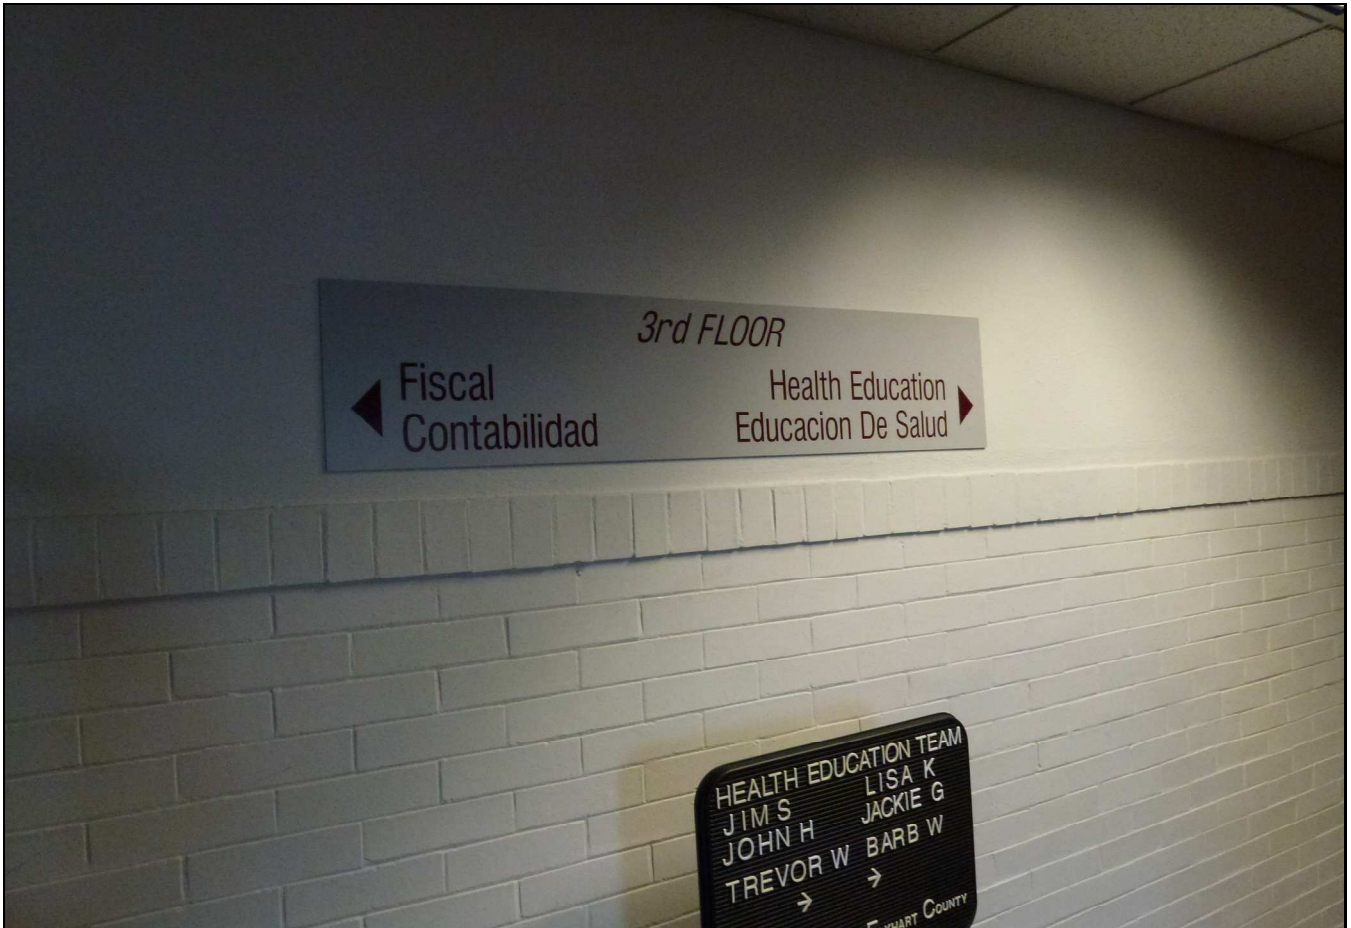
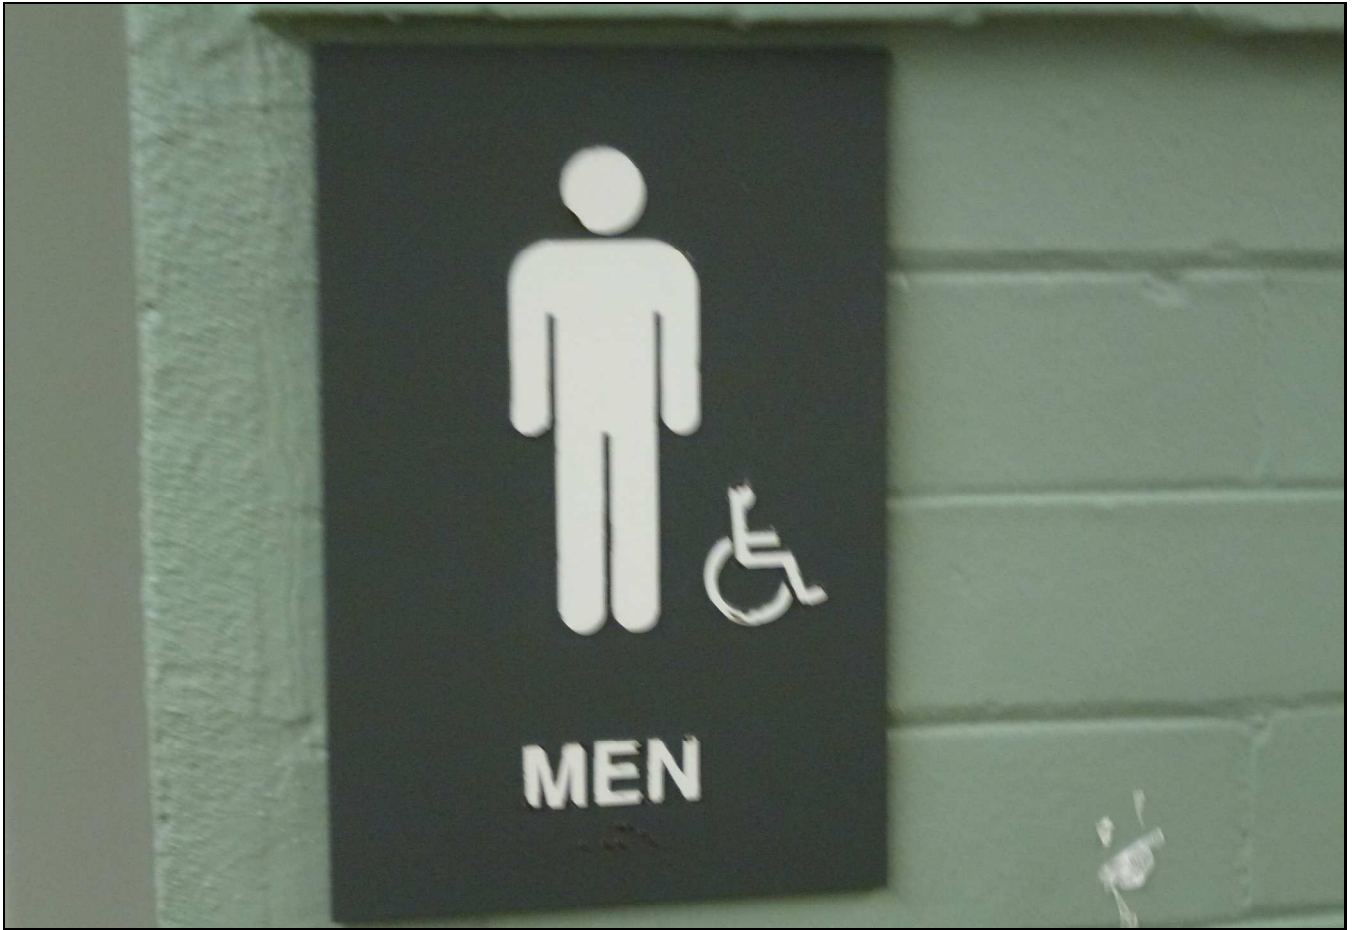
04. Elkhart Health Dept General Signage

3. Signage for goods and services, entire building	4, 5	Signs are mounted too high and some do not contain Grade II Braille	4.30	ADAAG requires signage to be mounted 60" from the floor, on the wall adjacent to latch side of door, to have raised characters and Braille text. Lower signage and add Grade II Braille text.	L: Signs are legible and provide direction.	\$4,000	Elkhart County General Fund
